## Devil's Slide/Hwy 1 Storm Repair

Daily Updates from Bijan Sartipi

**Daily Update**  
July 14

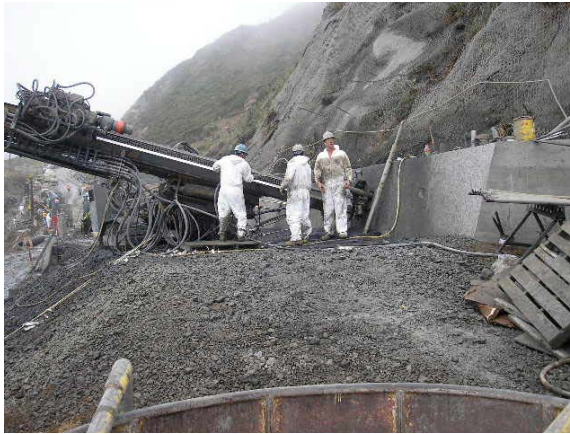
Drilling at level D – south end of wall

- Level 'B' (lower level ocean side) – All 58 tie backs now installed as of July 13. Tie back stressing continued.
- Level 'D' (upper level cliff side) – Drilling for tie backs continued today from the bench. 31 of 33 now installed. Cable stressing continued.

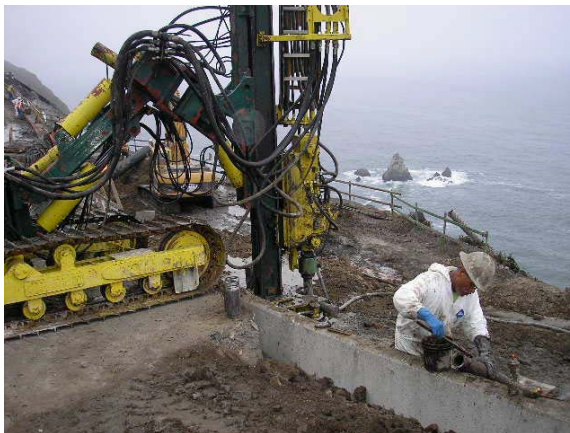
Micropile drilling

- Drilling and driving steel piles continued today. 55 of 99 now installed.

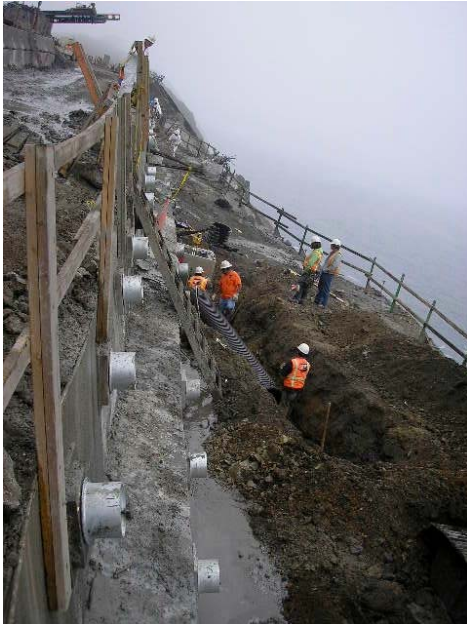
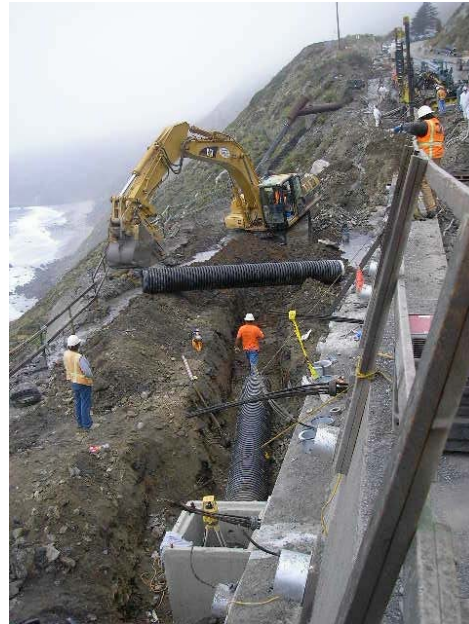
- Installing surface drains below level B is well underway as can be seen from the photos below.
